2020

MRCC Significant Tree Register

***A Reference Guide to Significant Trees on Council
Land in the Municipality of Mildura***

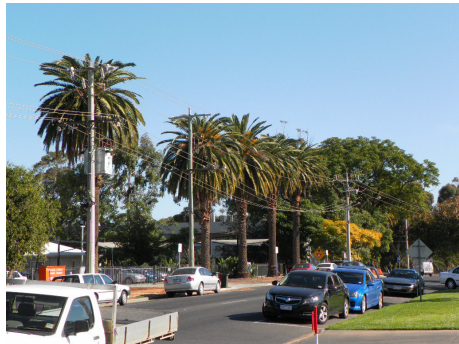
Identification:	Common Name:	Canary Island Date Palm

Genus & Species:	Phoenix canariensis	
	Tree Group Identifier No:	2	
	Tree No:	13-19	
Location & Access:	Location (Street Address or Park Name):	229-243 Thirteenth Street, Mildura	
	Access:	Unrestricted	
	GIS Coordinates:	6216737.3449999997 (N) / 605482.88 (E)	
For mapping please refer to Tree Group Identification No 2 on Mildura (Mildura West-D) town map in Appendix 1			
Assessment:	National Trust Australia (Vic) Heritage Register:	No	
	National Trust Australia (Vic) Criteria for Classification and Assessment:	Location or Context: Contribution to Landscape	
	MPS Heritage Overlay:	No	
	Heritage Victoria Criteria for Classification and Assessment:	Referred for Assessment in Stage 2 of MRCC Heritage Study Part B	
Field Description:	Tree Health:	Very Good	
	Tree Structure & Condition:	Good Structure	
	Note:	Comments below	
Dimensions:	Canopy (Planting Width/East West & North South Spread)	4m - 6m / Not Assessed

Measured Height:	Not Assessed	
	Measured DBH:	Not Assessed	
	Overall Height Estimate:	3m - 6m	
Threats & Remedies:	Threats:	13 Proximity to water mains/fire services and Overhead electric lines.	
		14-17 Proximity to overhead electric lines.	
		18-19 Levels and permeability have recently changed due to construction.	
	Remedial Action:	Educate land managers about suitable maintenance options in close proximity to the tree. Minimise damage to base of the palm trees.	
Comments:	Trees are pruned every 12-18 months to remove dead fronds and fruit.		
	Assessment Completed by:	Gareth Tyson	
	Assessment Completed date:	10 May 2012

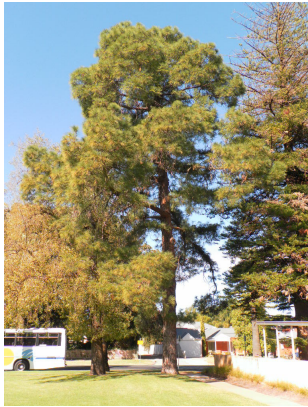
Identification:	Common Name:	Canary Island Pine

Genus & Species:	<i>Pinus canariensis</i>	
	Tree Group Identifier No:	6	
	Tree No:	23	
Location & Access:	Location (Street Address or Park Name):	199 Cureton Avenue, Mildura, Rio Vista House, Mildura	
	Access:	Unrestricted	
	GIS Coordinates:	6217529.7460000003 (N) / 606828.90000000002 (E)	
<i>For mapping please refer to Tree Group Identification No 6 on Mildura (Arts Centre-A) town map in Appendix 1</i>			
Assessment:	National Trust Australia (Vic) Heritage Register:	No	
	National Trust Australia (Vic) Criteria for Classification and Assessment:	Location or Context: Contribution to Landscape	
	MPS Heritage Overlay:	Tree covered by HO307 in the Mildura Planning Scheme	
	Heritage Victoria Criteria for Classification and Assessment:	Referred for Assessment in Stage 2 of MRCC Heritage Study Part B	
Field Description:	Tree Health:	Very Good	
	Tree Structure & Condition:	Good Structure

Note:	Comments below	
Dimensions:	Canopy (Planting Width/East West & North South Spread)	4m - 6m / EW 12m NS 17m	
	Measured Height:	23.5m	
	Measured DBH:	0.8m	
	Overall Height Estimate:	3m - 6m	
Threats & Remedies:	Threats:	Redevelopment of Rio Vista, footpath maintenance of the adjoining path which runs in along the property boundary to the house and gallery.	
	Remedial Action:	Ensure tree is protected during any reconstruction of the path in close proximity.	
Comments:	No comment required.		
	Assessment Completed by:	Gareth Tyson	
	Assessment Completed date:	10 May 2012

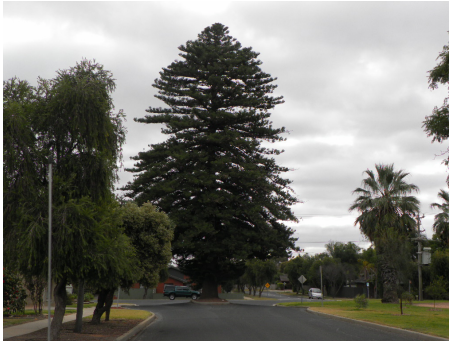
Identification:	Common Name:	Norfolk Island Pine

Genus & Species:	Araucaria heterophylla	
	Tree Group Identifier No:	9	
	Tree No:	50	
Location & Access:	Location (Street Address or Park Name):	Walnut Avenue end of Sandpiper Drive, Mildura	
	Access:	Unrestricted	
	GIS Coordinates:	6216015.9479999999 (N) / 605520.71499999997 (E)	
For mapping please refer to Tree Group Identification No 9 on Mildura (Mildura West-D) town map in Appendix 1			
Assessment:	National Trust Australia (Vic) Heritage Register:	No	
	National Trust Australia (Vic) Criteria for Classification and Assessment:	Location or Context: Contribution to Landscape Outstanding Size	
	MPS Heritage Overlay:	No	
	Heritage Victoria Criteria for Classification and Assessment:	Referred for Assessment in Stage 2 of MRCC Heritage Study Part B	
Field Description:	Tree Health:	Good	
	Tree Structure & Condition:	Good Structure	
	Note:	Comments below

Dimensions:	Canopy (Planting Width/East West & North South Spread)	4m - 6m / Not Assessed	
	Measured Height:	23.5m	
	Measured DBH:	Not Assessed	
	Overall Height Estimate:	3m - 6m	
Threats & Remedies:	Threats:	Road maintenance in the immediate vicinity surrounding the tree, dry conditions/reduced rainfall	
	Remedial Action:	Ensure tree is protected during any reconstruction of the road which is in close proximity to the base of the trunk.	
Comments:	No comment required.		
	Assessment Completed by:	Gareth Tyson	
	Assessment Completed date:	14 May 2012

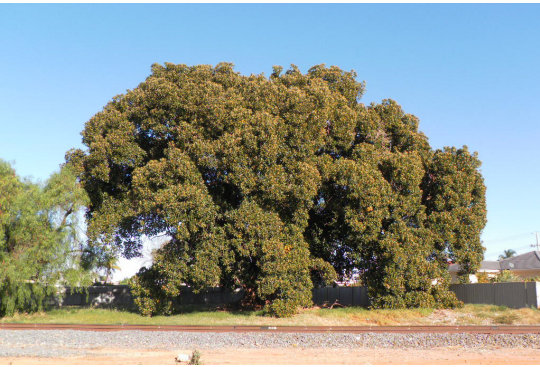
Identification:	Common Name:	Moreton Bay Fig

Genus & Species:	<i>Ficus macrophylla</i>	
	Tree Group Identifier No:	10	
	Tree No:	51	
Location & Access:	Location (Street Address or Park Name):	65 Douglas Avenue, Mildura	
	Access:	Unrestricted	
	GIS Coordinates:	6216152.0769999996 (N) / 607607.58200000005 (E)	
	<i>For mapping please refer to Tree Group Identification No 10 on Mildura (Mildura East-E) town map in Appendix 1</i>		
Assessment:	National Trust Australia (Vic) Heritage Register:	Yes	
	National Trust Australia (Vic) Criteria for Classification and Assessment:	Location or Context: Contribution to Landscape Rare or Localised Outstanding Size	
	MPS Heritage Overlay:	Trees covered by HO205 in the Mildura Planning Scheme	
	Heritage Victoria Criteria for Classification and Assessment:	Referred for Assessment in Stage 2 of MRCC Heritage Study Part B	
Field Description:	Tree Health:	Good	
	Tree Structure & Condition:	Good Structure

Note:	Comments below	
Dimensions:	Canopy (Planting Width/East West & North South Spread)	4m - 6m / Not Assessed	
	Measured Height:	Not Assessed	
	Measured DBH:	Not Assessed	
	Overall Height Estimate:	3m - 6m	
Threats & Remedies:	Threats:	Garden/lawn maintenance activities., the redevelopment of commercial properties has seen some nature strips in this section of Orange Avenue paved with pebblecrete reducing the permeability.	
	Remedial Action:	Educate land managers about suitable maintenance options in close proximity to the tree. Minimise damage to base of the palm trees.	
Comments:	Trees are pruned every 12-18 months to remove dead fronds and fruit.		
Assessment Completed by:		Gareth Tyson	Assessment Completed date: 14 May 2012

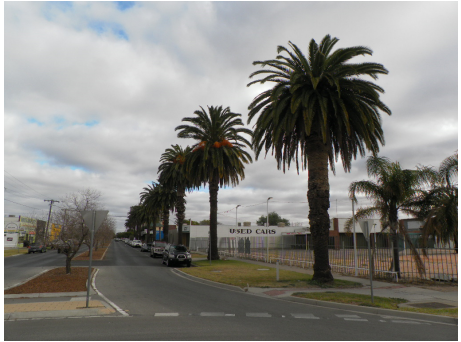
Identification:	Common Name:	Palm
	Genus & Species:	<i>Phoenix sp.</i>
	Tree Group Identifier No:	11
	Tree No:	59

Location & Access:	Location (Street Address or Park Name):	71 Orange Avenue, Mildura
	Access:	Unrestricted
	GIS Coordinates:	6216418.5590000004 (N) / 607218.03000000003 (E)
<i>For mapping please refer to Tree Group Identification No 11 on Mildura (CBD-B) town map in Appendix 1</i>		
Assessment:	National Trust Australia (Vic) Heritage Register:	No
	National Trust Australia (Vic) Criteria for Classification and Assessment:	Location or Context: Contribution to Landscape
	MPS Heritage Overlay:	No
	Heritage Victoria Criteria for Classification and Assessment:	Referred for Assessment in Stage 2 of MRCC Heritage Study Part B
Field Description:	Tree Health:	Very Good
	Tree Structure & Condition:	Good Structure
	Note:	Comments below
Dimensions:	Canopy (Planting Width/East West & North South Spread)	4m - 6m / Not Assessed

Measured Height:	Not Assessed
	Measured DBH:	Not Assessed
	Overall Height Estimate:	3m - 6m
Threats & Remedies:	Threats:	Garden/lawn maintenance activities., the redevelopment of commercial properties has seen some nature strips in this section of Orange Avenue paved with pebblecrete reducing the permeability.
	Remedial Action:	Educate land managers about suitable maintenance options in close proximity to the tree. Minimise damage to base of the palm trees.
Comments:	Trees are pruned every 12-18 months to remove dead fronds and fruit.	
Assessment Completed by: Gareth Tyson		Assessment Completed date: 14 May 2012

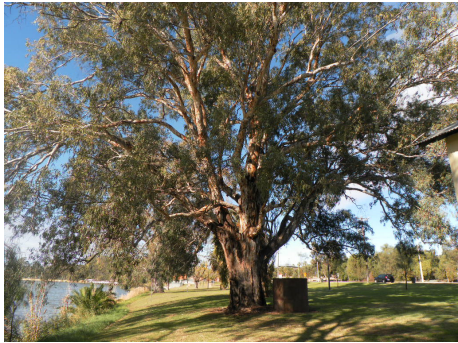
Identification:	Common Name:	Red Gum
	Genus & Species:	<i>Eucalyptus camaldulensis</i>
	Tree Group Identifier No:	40
	Tree No:	265

Location & Access:	Location (Street Address or Park Name):	Riverfront, Mildura (Near old pump building opposite Powerhouse) & Jaycee Park, Mildura
	Access:	Unrestricted
	GIS Coordinates:	6217208.7980000004 (N) / 607333.73199999996 (E)
<i>For mapping please refer to Tree Group Identification No 40 on Mildura (CBD-B) town map in Appendix 1</i>		
Assessment:	National Trust Australia (Vic) Heritage Register:	No
	National Trust Australia (Vic) Criteria for Classification and Assessment:	Location or Context: Contribution to Landscape
	MPS Heritage Overlay:	No
	Heritage Victoria Criteria for Classification and Assessment:	Referred for Assessment in Stage 2 of MRCC Heritage Study Part B
Field Description:	Tree Health:	Good
	Tree Structure & Condition:	Good Structure
	Note:	Comments below

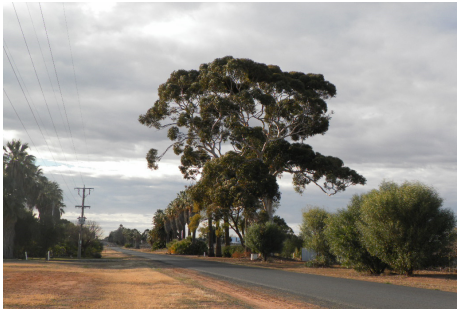
Identification:	Common Name:	Sugar Gum

Genus & Species:	<i>Eucalyptus cladocalyx</i>	
	Tree Group Identifier No:	52	
	Tree No:	373	
Location & Access:	Location (Street Address or Park Name):	309 Third Street, Merbein	
	Access:	Unrestricted	
	GIS Coordinates:	6219335.7039999999 (N) / 594608.50800000003 (E)	
<i>For mapping please refer to Tree Group Identification No 52 on Merbein (Key) town map in Appendix 1</i>			
Assessment:	National Trust Australia (Vic) Heritage Register:	No	
	National Trust Australia (Vic) Criteria for Classification and Assessment:	Location or Context: Contribution to Landscape Rare or localised	
	MPS Heritage Overlay:	No	
	Heritage Victoria Criteria for Classification and Assessment:	Referred for Assessment in Stage 2 of MRCC Heritage Study Part B	
Field Description:	Tree Health:	Good	
	Tree Structure & Condition:	Poor - Co-dominant or Bifurcated Stems	
	Note:	Comments below

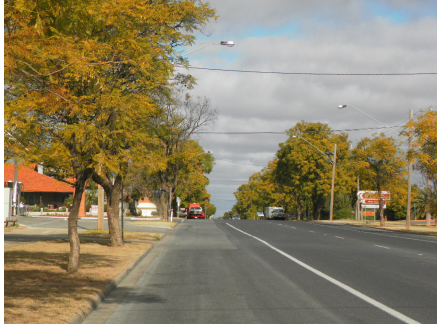
Identification:	Common Name: Jacaranda Genus & Species: <i>Jacaranda mimosifolia</i> Tree Group Identifier No: 55 Tree No: 376-413

Location & Access:	Location (Street Address or Park Name): Access: GIS Coordinates:	3-101 Jacaranda Street, Red Cliffs 1 Indi Avenue, Red Cliffs Unrestricted 6202603.8119999999 (N) / 609176.174 (E) <i>For mapping please refer to Tree Group Identification No 55 on Red Cliffs (Barclay Square) town map in Appendix 1</i>
Assessment:	National Trust Australia (Vic) Heritage Register: National Trust Australia (Vic) Criteria for Classification and Assessment: MPS Heritage Overlay: Heritage Victoria Criteria for Classification and Assessment:	No Location or Context: Contribution to Landscape No Referred for Assessment in Stage 2 of MRCC Heritage Study Part B
Field Description:	Tree Health: Tree Structure & Condition: Note:	Good 376-383, 385-389, 392-395, 399, 401-405, 407-412 Good Structure 384, 390, 396, 413 Poor – Co-dominant or Bifurcated Stem 391, 397 Poor - Major Trunk Wound 398, 400, 406 Poor – Trunk Decay Comments below

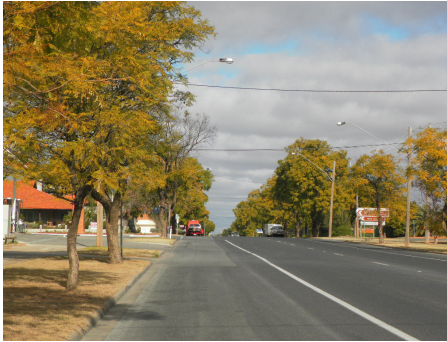
Identification:	Common Name:	Jacaranda

Genus & Species:	Jacaranda mimosifolia	
	Tree Group Identifier No:	55	
	Tree No:	478-480	
Location & Access:	Location (Street Address or Park Name):	Calder Highway, Red Cliffs (Heading to Werrimull Road from Red Cliffs)	
	Access:	Unrestricted	
	GIS Coordinates:	6201876.7149999999 (N) / 609170.38300000003 (E)	
For mapping please refer to Tree Group Identification No 55 on Red Cliffs (Barclay Square) town map in Appendix 1			
Assessment:	National Trust Australia (Vic) Heritage Register:	No	
	National Trust Australia (Vic) Criteria for Classification and Assessment:	Location or Context: Contribution to Landscape	
	MPS Heritage Overlay:	No	
	Heritage Victoria Criteria for Classification and Assessment:	Referred for Assessment in Stage 2 of MRCC Heritage Study Part B	
Field Description:	Tree Health:	Good	
	Tree Structure & Condition:	Poor - Co-dominant or Bifurcated Stems
