MALLEE AREA REVIEW
STUDY OF HISTORIC SITES

Prepared by
Andrew C. Ward & Associates

for the
LAND CONSERVATION COUNCIL

May, 1986

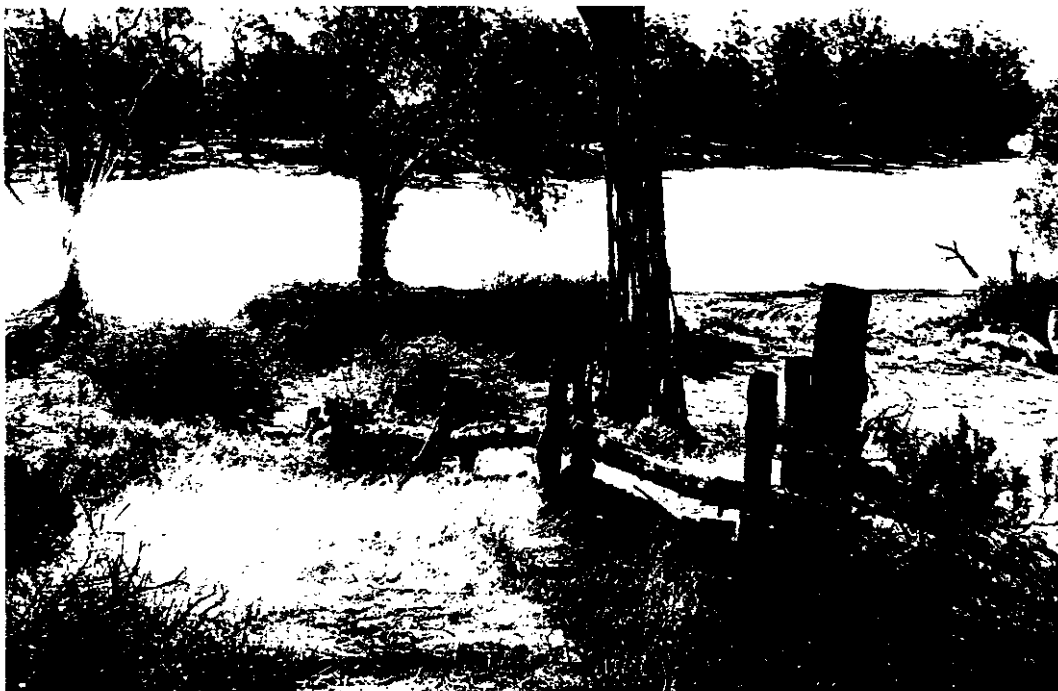
Item: Pine log fence: "Kulnine" homestead
Location: near the station homestead site

Inspection: April 1986
Map Reference: 1:100,000, Wentworth, 7229
GR: 62.14, 5.49
Historic Theme: 1.3.2 Pastoral
Construction Date:
Constructing Agency:
Alterations: Partly replaced by recent fencing.
Description: A Murray pine log fence in the traditional form consisting of pairs of posts at regular intervals with up to five logs dropped in between the paired posts.
Condition: Fair
Integrity: Good
History: Associated with the "Kulnine" homestead site.
Significance: C. A valuable remnant of the homestead, possibly dating from its early years.
Recommendations: Retain

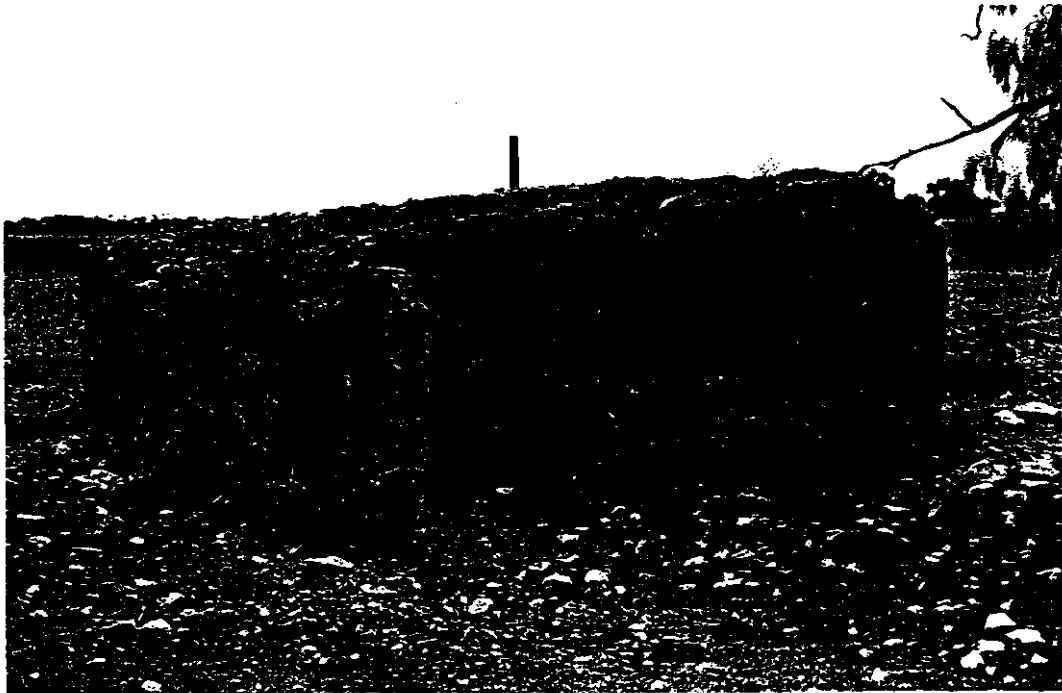
Item: Ruins (lime burning kilns?)

Description: The site is marked by two peppercorn trees and three stone buildings, with roofs removed. The largest has a concrete floor with space underneath and a small adjoining oven with domed brick ceiling, accessed by a small portal. The walls of all three structures are of limestone. A collapsed limestone fence marks out a yard connecting each building. They are possibly lime burning kilns.

C. If the assumption about lime burning kilns is correct, these curious and relatively complete ruins are important remnants of the Berook Settlement which employed limestone and lime mortar in the construction of its buildings.

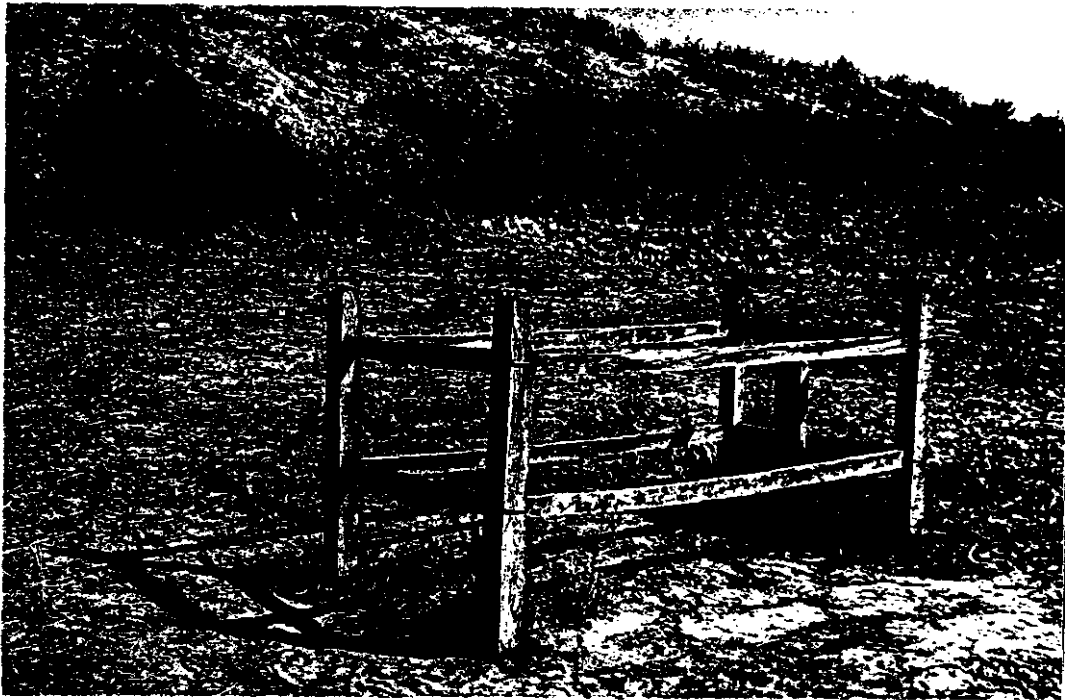
Location: Hattah-Kulkyne National Park

Description: A stockman's grave marked by a timber cross and encircled by a timber enclosure. Incised on the horizontal arm of the cross are the words: "James Mahon aged 63 found drowned in Chalka Creek Dec. 21 1923, inserted by L. & E. Mahon".

Condition: Good

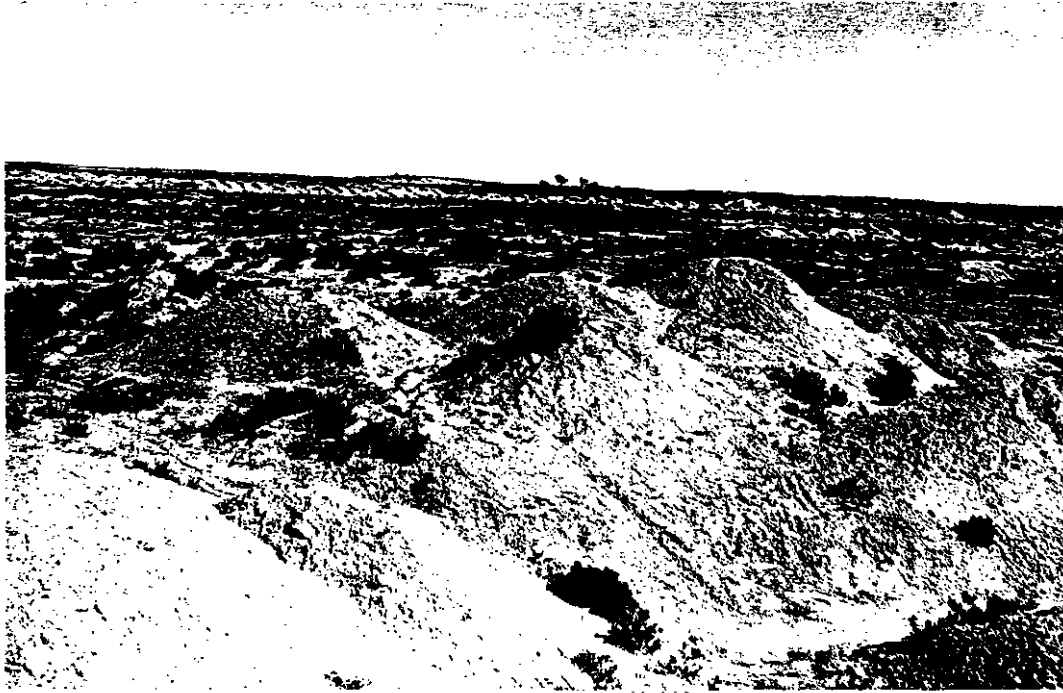
Item: Former gypsum mine
Location: Meridian Road, RAAK Plain

Inspection: April 1986
Map Reference: 1:100,000, Sunset, 7228
GR: 61.72, 5.91
Historic Theme: 5.4 Mining: Gypsum
Construction Date: c.1950
Constructing Agency: Mildura Plaster Mills Pty Ltd
Alterations: abandoned
Description: Extensive overburden dumps, partially overgrown.
Condition: Good
Integrity: Good
History: The mine was established here c.1950 and closed c.1978.
Significance: C. This site is of interest in so far as the development of the area's gypsum mining industry is concerned.
Recommendations: Retain
Sources: Mildura Plaster Mills Pty Ltd

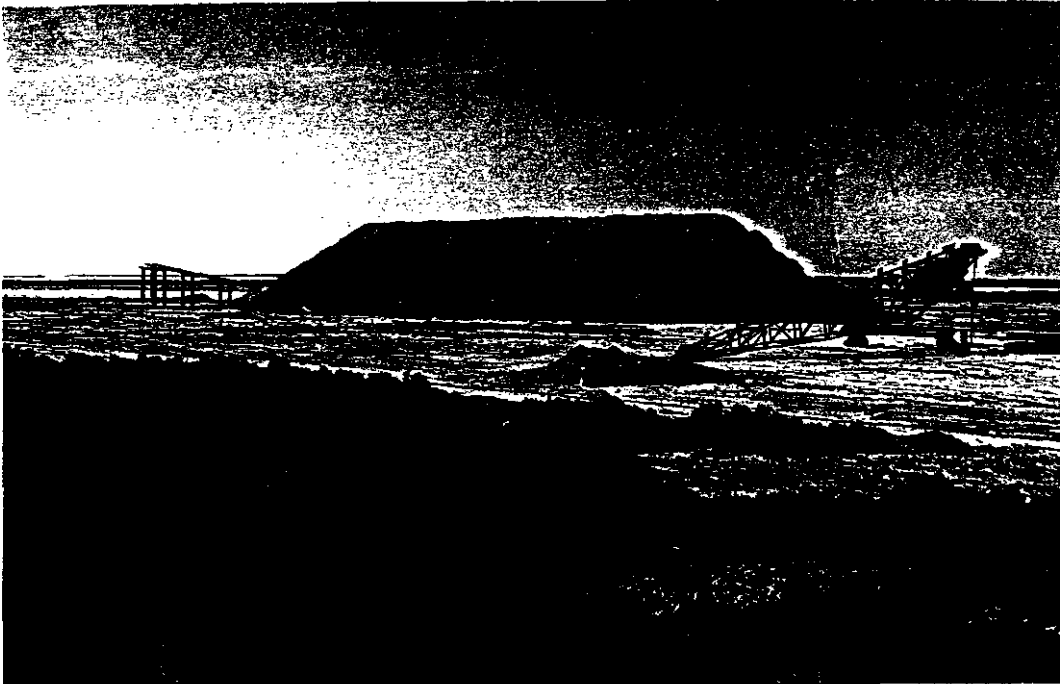
Item: Salt harvesting site: Lake Tyrrell
Location: Lake Tyrrell

Inspection: May 1986
Map Reference: 1:100,000, Tyrrell, 7427
GR: 60.79, 6.63
Construction Date:
Constructing Agency:
Alterations: Abandoned
Description: Mobile and fixed conveyor are situated near to a salt stockpile. To the west, workers huts have collapsed, whilst two abandoned trucks are located on a section of land extending out into the lake.
Condition: Poor

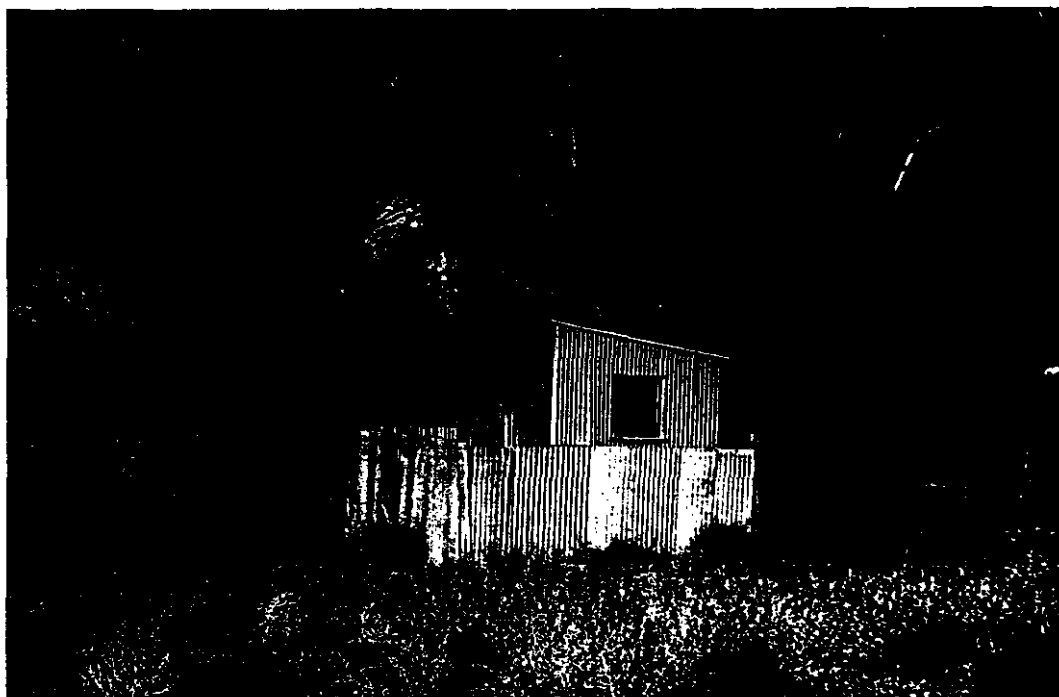
Item: Railway pumping station: Lake Hattah
Location: Hattah Lake

Inspection: April 1986
Map Reference: 1:100,000, Nowingi, 7328
GR: 61.53, 6.22
Historic Theme: 7.2 Transport
Construction Date: 1908
Constructing Agency: Victorian Railway Department (Designer:
Mr Lowry - Machinery and Water Supply)
Alterations: P.S. rebuilt, 1944
Description: A timber framed corrugated iron clad shelter with
corrugated iron perimeter fence and suction pipe on
pile frame in Lake Hattah. A Lister diesel engine
rope drives an Ajax type A6, series E, force pump,

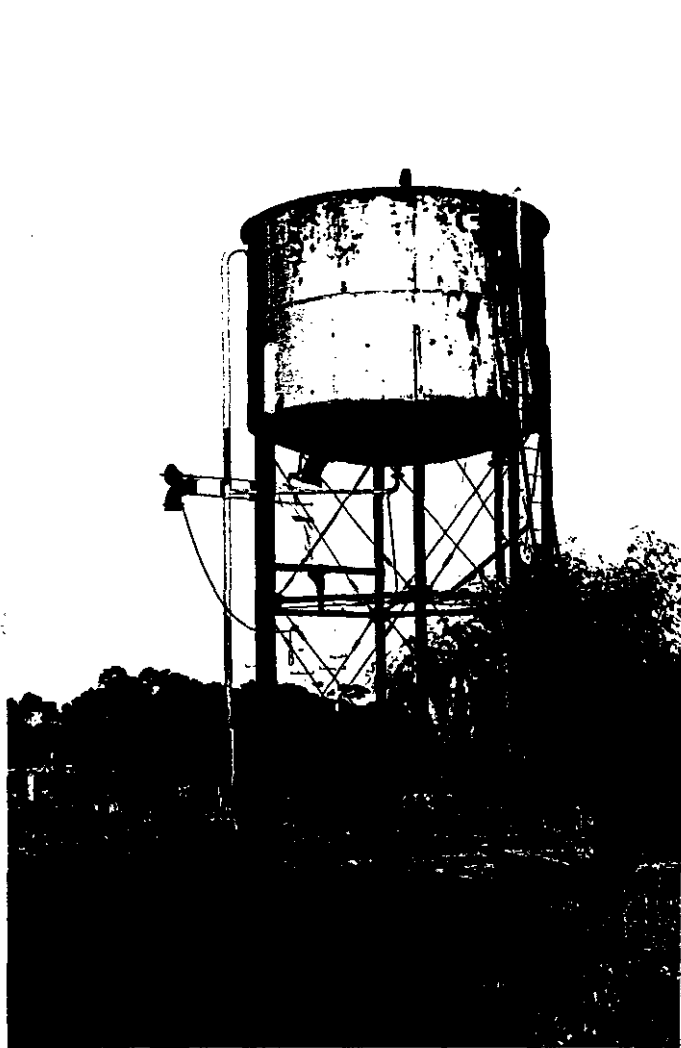
Item: Combined water tank and crane
Location: Hattah railway station

Inspection: April 1986
Map Reference: 1:100,000, Nowingi, 7328
GR: 61.52, 6.17
Historic Theme: 7.2 Transport

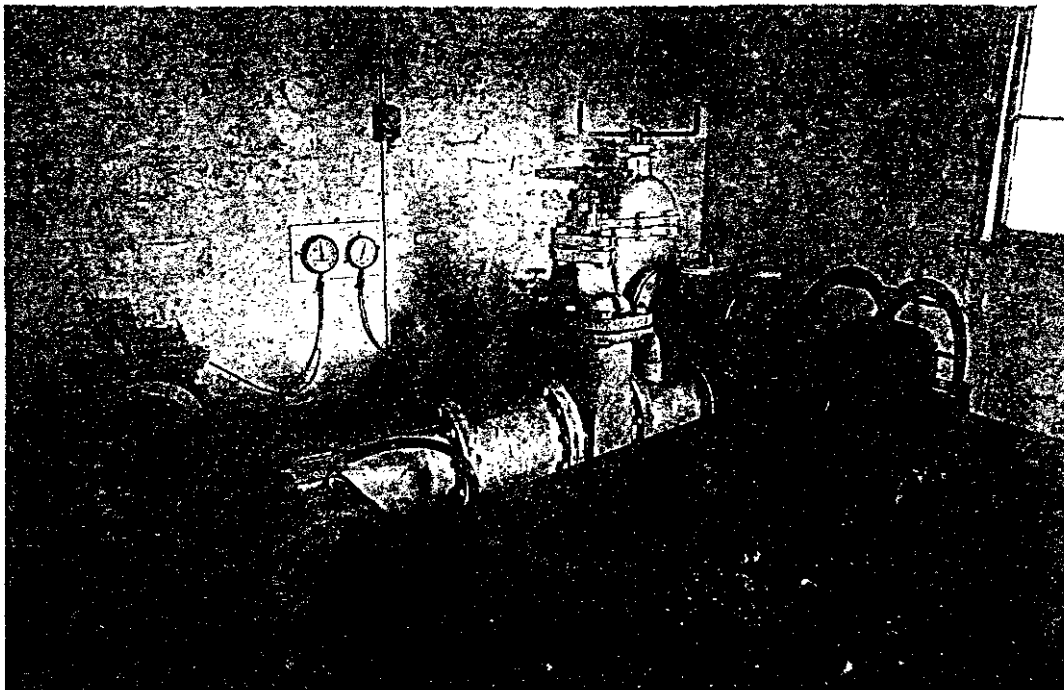
Item: Robinvale E Re-lift
Location: At lot 63, Robinvale Irrigation Settlement

Inspection: April, 1986
Map Reference: 1:100,000, Robinvale, 7428
GR 61.66, 6.59
Historic Theme: 7.3 Services (water)
Construction Date: 1950
Constructing Agency: Former State Rivers and Water Supply Commission
Alterations: Conversion from diesel to electric power: 1956
Description: A small cement block, corrugated iron gable roofed building on a concrete slab, accommodating one unit as follows:

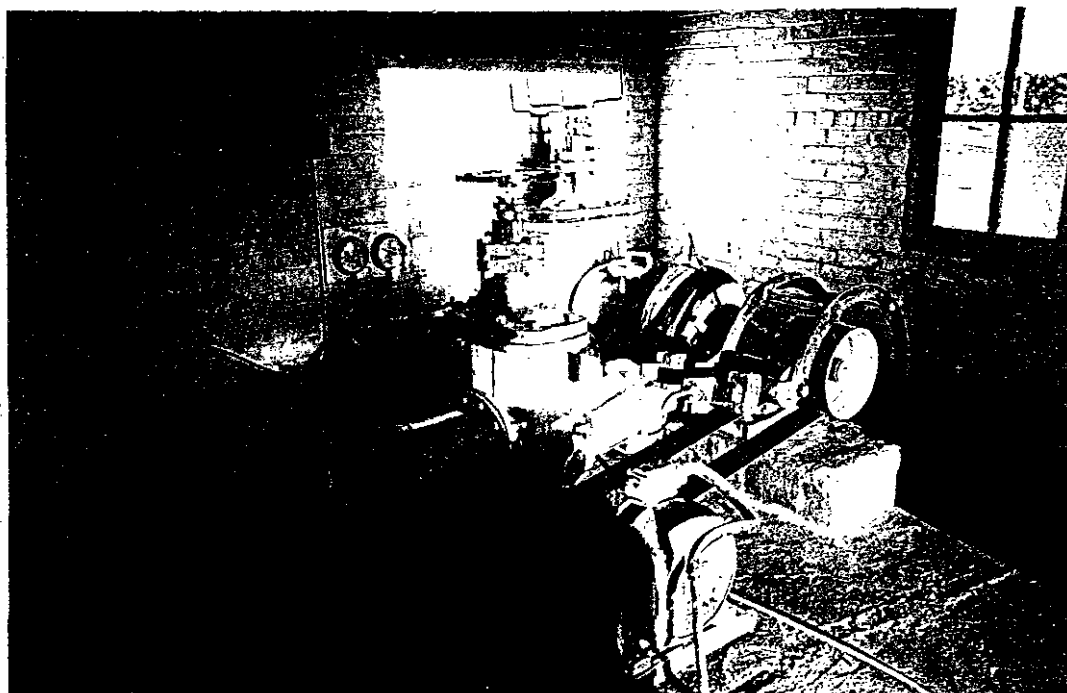
Item: Robinvale F Relift
Location: At lot 103, Robinvale Irrigation Settlement

Historic Theme: 7.3 Services (water)
Construction Date: 1955
Constructing Agency: Former State Rivers and Water Supply Commission
Alterations: Electrification: 1976
Description: A small cement block building with parapetted walls and skillion roof, accommodating 2 units as follows:

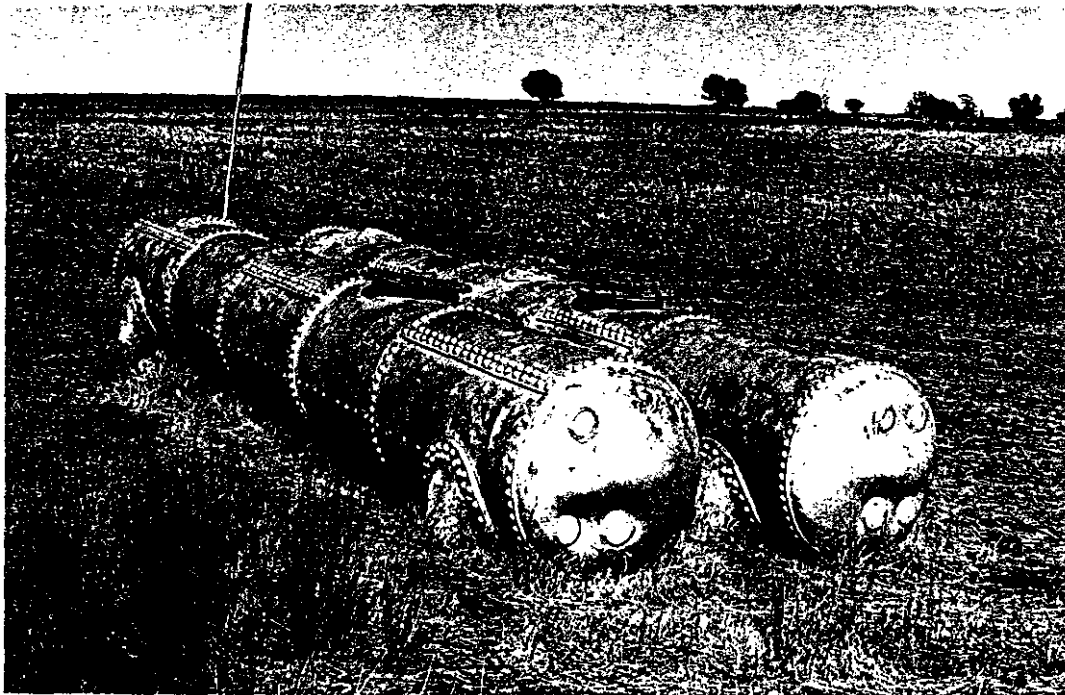
Item: Coreena Pumping Station
Location: Murray Valley Highway: Wemen to Bannerton Section

Inspection: April, 1986
Map Reference: 1:100,000 Robinvale, 7428
GR 61.55, 6.58
Historic Theme: 7.3 Services (water)
Construction Date: 1985
Constructing Agency: Rural Water Commission
Alterations: -
Description: The present p.s. is not of historic significance, elements of the former Coreena p.s. built 1947, incorporated in the present structure not being of interest.
Two boiler drums ex Robinvale main p.s. were made by Rees and removed to Coreena as fuel storage tanks post 1956. They remain on site, with inspection dates commencing 1978.

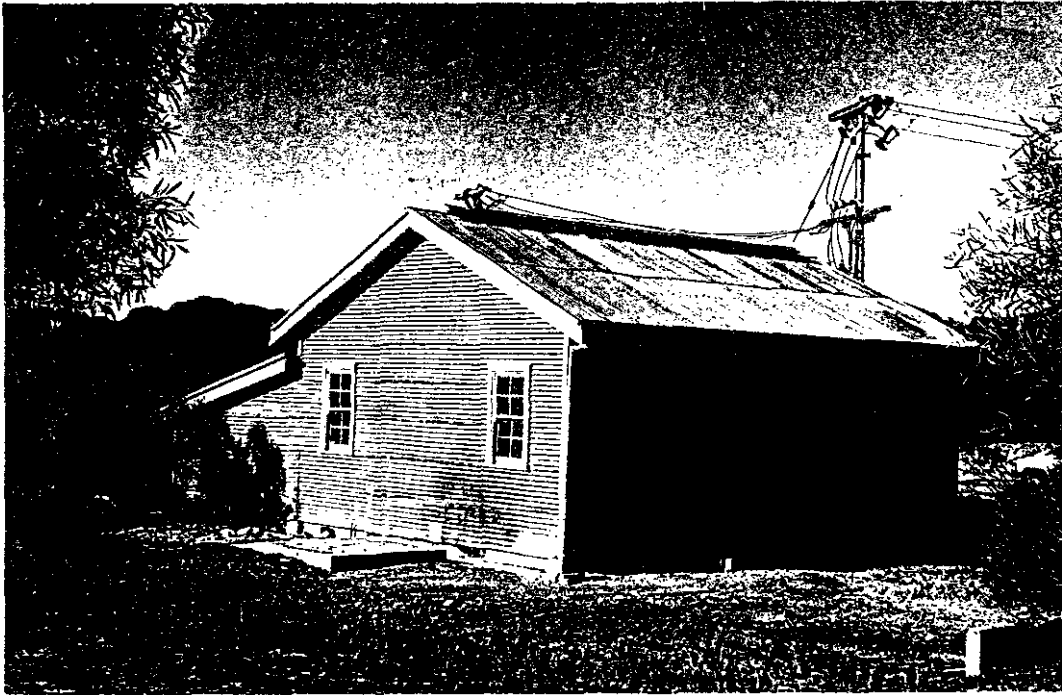
Item: Walpeup High Lift p.s.
Location: Torrita Channel, south of Walpeup

Item: April, 1986
Map Reference: 1:100,000, Ouyen 7327
GR
Historic Theme: 7.3 Services (water)
Construction Date: 1931
Constructing Agency: Former State Rivers and Water Supply Commission
Alterations: electrification
Description: A corrugated iron, steel and timber framed , gable roofed building on concrete slab, fed by the Torrita channel off the Dennyning main channel. Original Blackstone diesel engines (2) have been removed along with their pumps. Two Thompson's 8"/10" Type CL Brook centrifugal pumps are powered off 2 Brook electric motors.

<u>Condition:</u>	Good
<u>Integrity:</u>	Fair
<u>History:</u>	Built in 1931 to provide water for domestic and stock purposes and urban purposes at Walpeup township, this p.s. is now threatened by pipe line proposals.
<u>Significance:</u>	C. The p.s. is of local significance for its role in the district since 1931. The is intact, and was the last of the Mallee district stock and domestic stations to be built prior to the present era, commencing in the 1970's.
<u>Recommendations:</u>	Protect
<u>Sources:</u>	<ul style="list-style-type: none">- R W C- J. McCechnie- RHSV: "The Victorian Historical Magazine", November, 1967

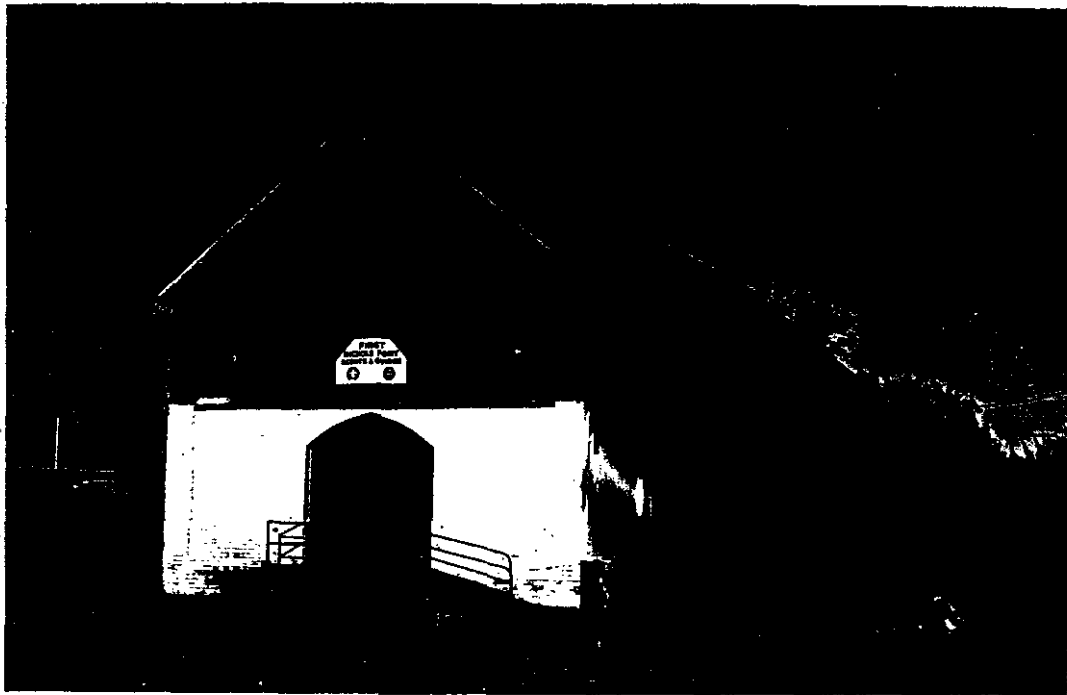
Item: Nichols Point Pumping Station
Location: Corner Cureton Avenue and Cemetery Road, Mildura

Inspection: April, 1986
Map Reference: 1:100,000 Mildura 7329
GR 62.15, 6.10
Historic Theme: 7.3 Services (water)
Construction Date: 1890
Constructing Agency: The Mildura Irrigation Company
Alterations: Closure and removal of plant:
Description: The Nichols Point station lifted water from the 52 foot to the 70 foot level.
Condition: Good
Integrity: Poor

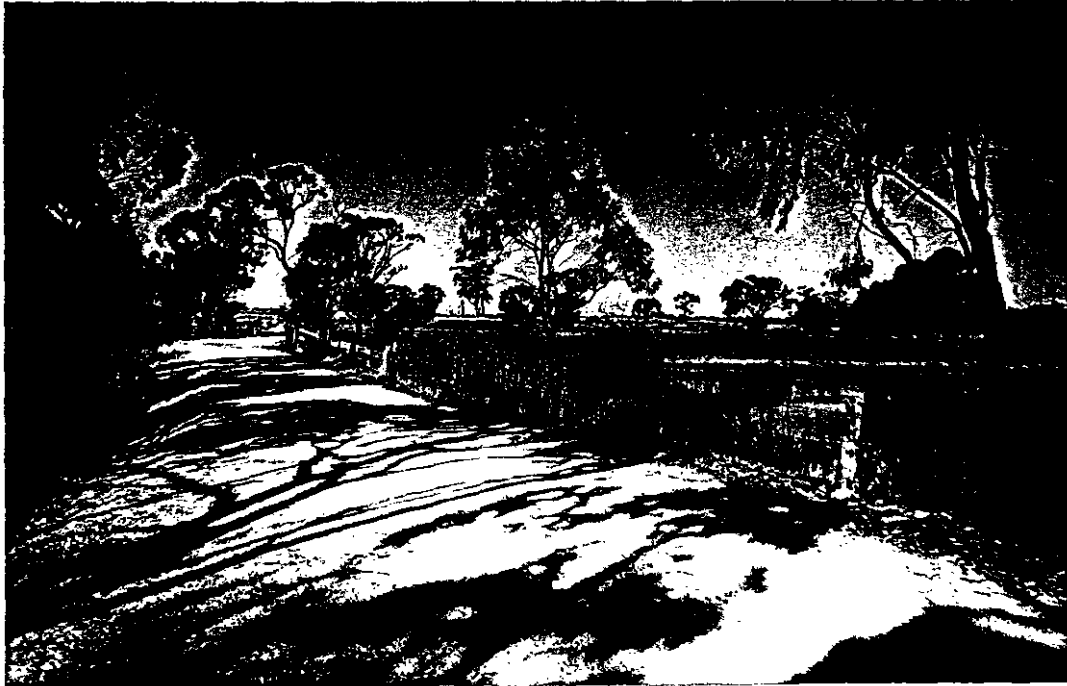
Item: Reservoir: Yarrambiack Creek
:Location: "Corrong"

Historic Theme: 7.3 Services (water)
Map Reference: 1:100,000, Hopetoun, 7326
GR 60.42, 6.24
Construction Date: 1891
Constructing Agency: E.H. Lascelles
Alterations:
Description: An earth causeway carrying a rough track and generally of use only when the creek flows.
Condition: Good
Integrity: Good
History:
Significance: B. Lascelles pioneering work supplying water to the township of Hopetoun and irrigating the surrounding farms is of regional importance.
Recommendations: Protect
Sources:

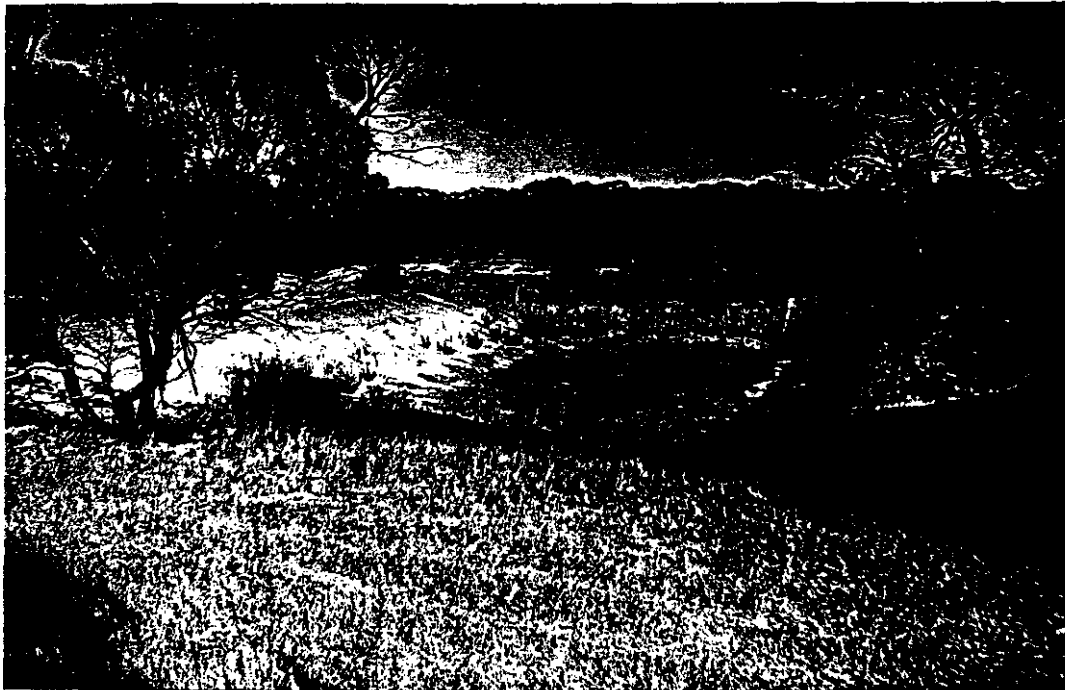
Item: Bugge's public tank
Location: Patchewollock - Pine Plains Road

Inspection : May 1986
Map Reference: 1:100,000, Ouyen, 7327
GR: 60.83, 6.02
Historic Theme: 7.3 Services (water)
Construction Date:
Constructing Agency: Former State Rivers and Water Supply Commission
Alterations: nil
Description: Earth tank with gauge pole and two concrete inlet chutes.
Condition: Fair
Integrity: Good
History:

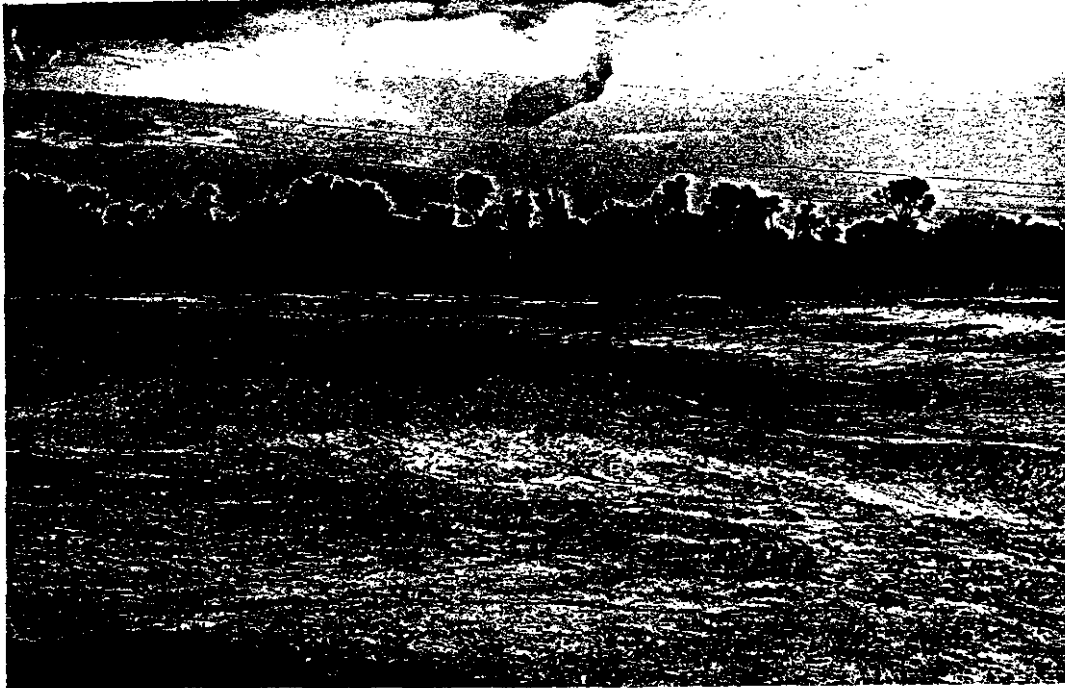
Item: Congereel tank
Location: 7 kilometres south of Nowingi

Inspection: April 1986
Map Reference: 1:100,000, Nowingi, 7228
GR: 61.63, 6.13
Historic Theme: 7.3 Services: water
Construction Date:
Constructing Agency:
Alterations: nil
Description:
Condition: Good
Integrity: Good
History: This tank was known as Gower's tank and was originally constructed c.1880's prior to closer settlement. (H. MacArthur)
Significance: C.
Recommendations: nil
Sources: H. MacArthur

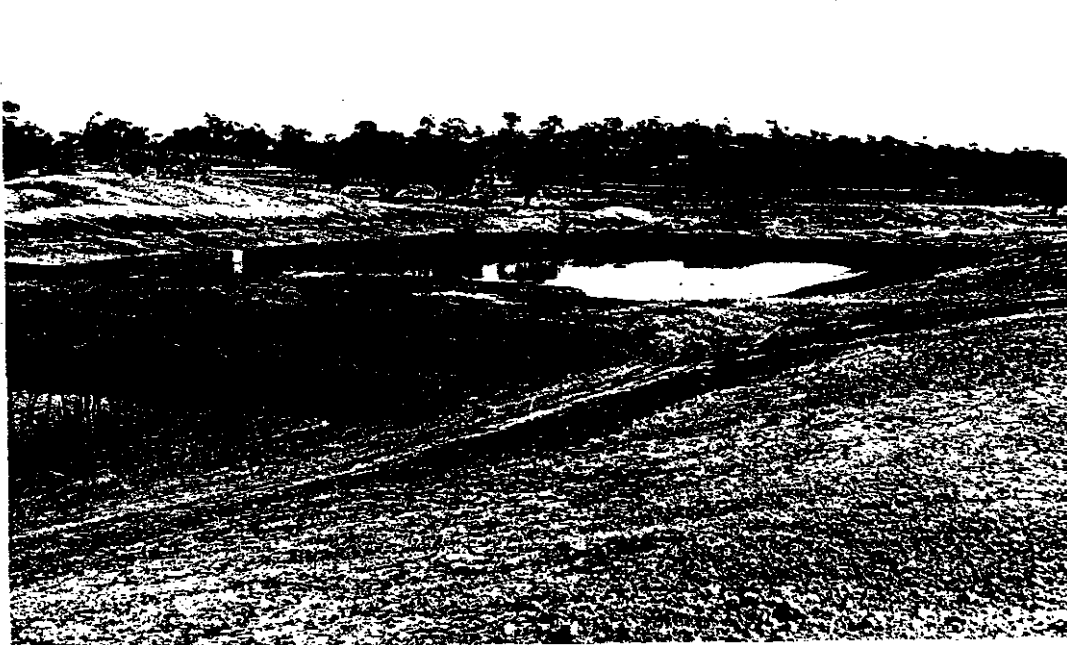
Item: Brighton Tank
Location: 11 kilometres north-west of Nowingi

Inspection: April 1986
Map Reference: 1:100,000, Nowingi, 7228
GR 61.74, 6.01
Historic Theme: 7.3 Services: water
Construction Date:
Constructing Agency:
Alterations: nil
Description: Two tanks with graded catchment
Condition: Good
Integrity: Good
History: This tank was in use on the "Mildura" pastoral run,
prior to closer settlement
(H. MacArthur)
Significance: C.
Recommendations: nil
Sources: H MacArthur

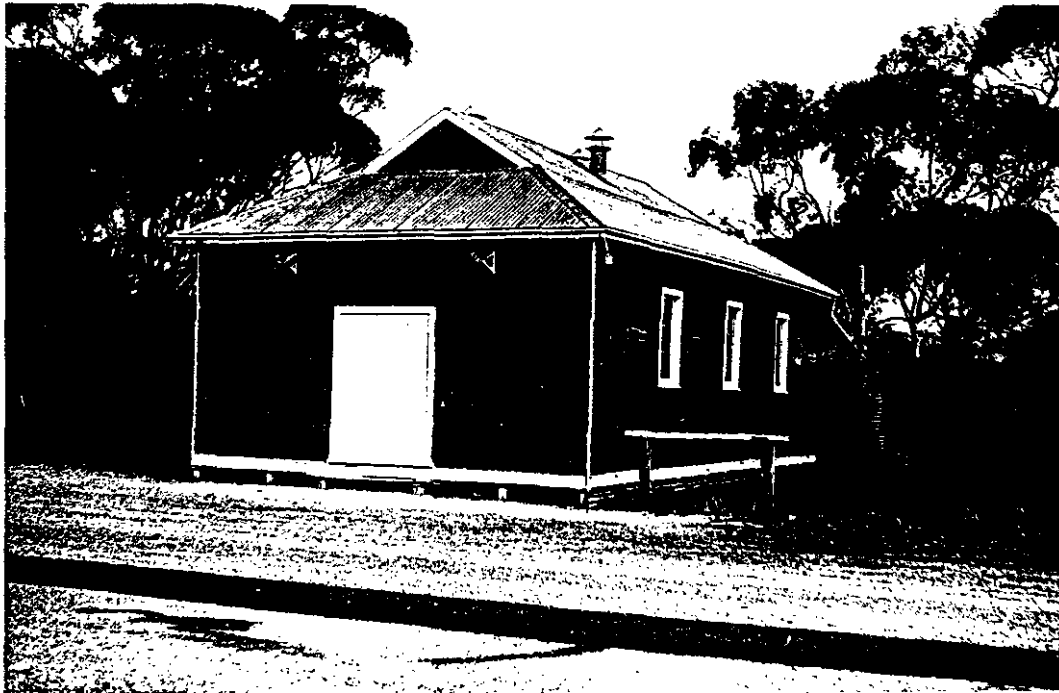
Item: Torrita Public Hall
Location: Ouyen Highway, Torrita

Inspection: May, 1986
Map Reference: 1:100,000, Underbool, 7227
GR: 61.09, 5.85
Historic Theme: 7.12 Public Halls
Construction Date:
Constructing Agency:
Alterations: nil
Description: A timber framed ripple iron clad building with Dutch gabled roof lined with corrugated iron and roof ventilators. The doors, windows, fascias and barges are the only timber elements. The roof and wall ventilators are expressed as part of the design. A murray pine hitching rail is located alongside.
Inside, the framing is expressed, the external linings also forming the internal linings.

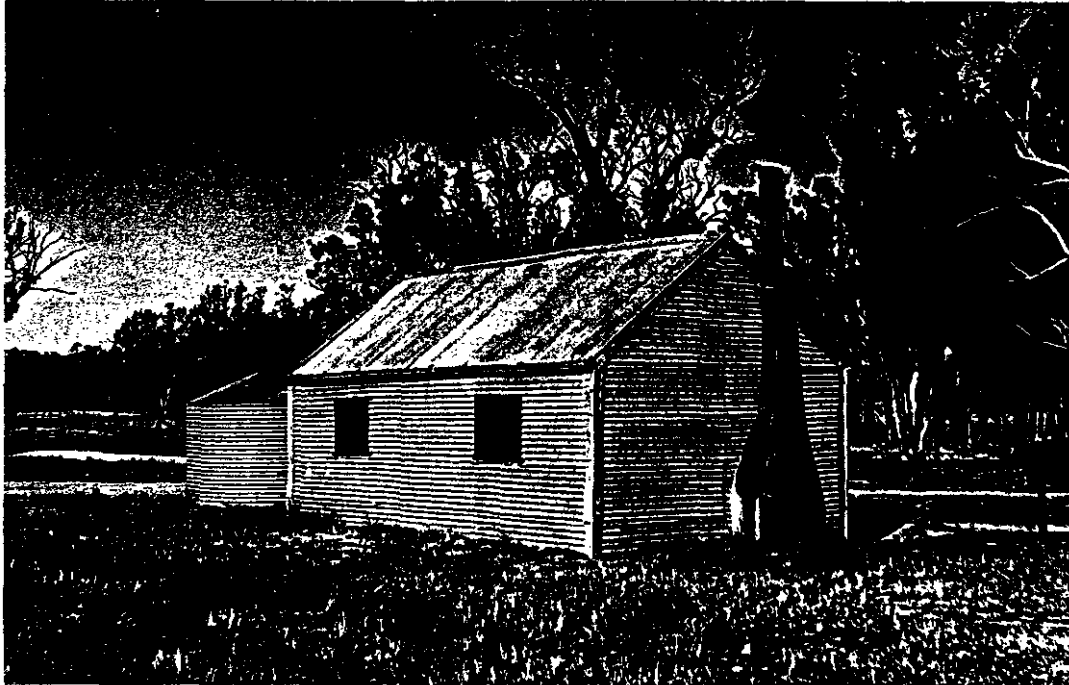
Item: Wonga Hut
Location: Wyperfeld National Park

Map Reference: 1:100,000
Map Reference: 1:100,000, Hopetoun, 7326
GR: 60.61, 5.95
Historic Theme: 7.11 Recreation
Construction Date: 1934
Constructing Agency: Former National Parks Service
Alterations:
Description: A gable roofed, timber framed and corrugated iron clad visitor's shelter, with perimeter seats and two tanks.
Condition: Good
Integrity: Good
History: The original Wonga Hut was a cypress pine log hut used by shepherds on the Wonga Lake run. It was burnt down or demolished, the present hut being built for the use of park visitors in 1934.
Significance: C. Of significance possibly as an early purpose built National Parks Service structure.
Recommendations: Maintain
Sources: C. F. & L. Departmental files.
