2020

MRCC Significant Tree Register

***A Reference Guide to Significant Trees on Council
Land in the Municipality of Mildura***

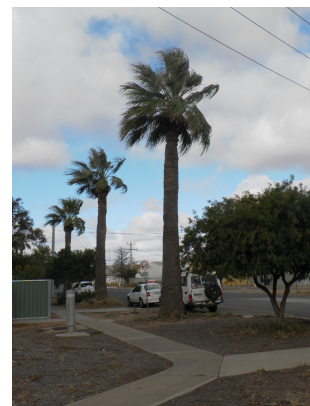
Identification:	Common Name:	Desert Fan Palm	 
	Genus & Species:	<i>Washingtonia filifera</i>	
	Tree Group Identifier No:	14	
	Tree No:	83-87	
Location & Access:	Location (Street Address or Park Name):	Ellswood Crescent, Mildura	
	Access:	Unrestricted	
	GIS Coordinates:	6215123.3140000002 (N) / 608471.03899999999 (E)	
<i>For mapping please refer to Tree Group Identification No 14 on Mildura (Mildura East-E) town map in Appendix 1</i>			
Assessment:	National Trust Australia (Vic) Heritage Register:	No	
	National Trust Australia (Vic) Criteria for Classification and Assessment:	Location or Context: Contribution to Landscape Aesthetic Value	
	MPS Heritage Overlay:	No	
	Heritage Victoria Criteria for Classification and Assessment:	Referred for Assessment in Stage 2 of MRCC Heritage Study Part B	
Field Description:	Tree Health:	Very Good	
	Tree Structure & Condition:	Good Structure	
	Note:	Comments below	
Dimensions:	Canopy (Planting Width/East West & North South Spread)	4m - 6m / Not Assessed

Measured Height:	Not Assessed	
	Measured DBH:	Not Assessed	
	Overall Height Estimate:	3m - 6m	
Threats & Remedies:	Threats:	Development of the adjoining vacant land for housing including construction of new road sections and driveway cross overs.	
	Remedial Action:	Ensure that trees are protected during the development of the vacant land and construction of formal kerb and guttering on the Northern side of Ellswood Crescent.	
Comments:	Trees are pruned every 12-18 months to remove dead fronds and fruit.		
	Assessment Completed by:	Gareth Tyson	
	Assessment Completed date:	41044

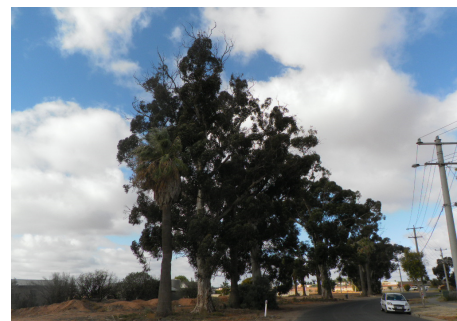
Tree No: **88-92**

Tree Structure & Condition: Good Structure

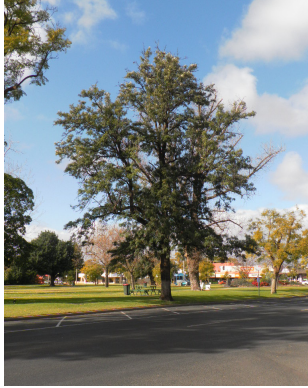
Identification:	Common Name:	Silky Oak
	Genus & Species:	<i>Grevillea robusta</i>
	Tree Group Identifier No:	17
	Tree No:	102
Location & Access:	Location (Street Address or Park Name):	Henderson Park, Mildura
	Access:	Unrestricted
	GIS Coordinates:	6215976.398 (N) / 606255.28700000001 (E)

<p><i>For mapping please refer to Tree Group Identification No 17 on Mildura (Henderson Park-C) town map in Appendix 1</i></p>		
Assessment:	National Trust Australia (Vic) Heritage Register:	No
	National Trust Australia (Vic) Criteria for Classification and Assessment:	Location or Context: Contribution to Landscape Aesthetic Value
	MPS Heritage Overlay:	No
	Heritage Victoria Criteria for Classification and Assessment:	Referred for Assessment in Stage 2 of MRCC Heritage Study Part B
Field Description:	Tree Health:	Poor
	Tree Structure & Condition:	Good Structure
	Note:	Comments below
Dimensions:	Canopy (Planting Width/East West & North South Spread)	4m - 6m / EW 12.3m NS 15m

Measured Height:	18m
	Measured DBH:	0.68m
	Overall Height Estimate:	3m - 6m
Threats & Remedies:	Threats:	Garden/lawn maintenance activities.
	Remedial Action:	Educate land managers about suitable maintenance options in close proximity to the tree.
Comments:	No comment required.	
	Assessment Completed by:	Gareth Tyson
	Assessment Completed date:	15 May 2012

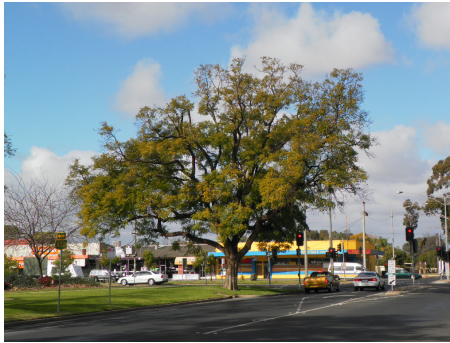
Identification:	Common Name:	Jacaranda

Genus & Species:	<i>Jacaranda mimosifolia</i>	
	Tree Group Identifier No:	18	
	Tree No:	103	
Location & Access:	Location (Street Address or Park Name):	Henderson Park, Mildura	
	Access:	Unrestricted	
	GIS Coordinates:	6215938.7149999999 (N) / 606290.56900000002 (E)	
	<i>For mapping please refer to Tree Group Identification No 18 on Mildura (Henderson Park-C) town map in Appendix 1</i>		
Assessment:	National Trust Australia (Vic) Heritage Register:	No	
	National Trust Australia (Vic) Criteria for Classification and Assessment:	Location or Context: Contribution to Landscape Aesthetic Value	
	MPS Heritage Overlay:	No	
	Heritage Victoria Criteria for Classification and Assessment:	Referred for Assessment in Stage 2 of MRCC Heritage Study Part B	
Field Description:	Tree Health:	Poor	
	Tree Structure & Condition:	Good Structure	
	Note:	Comments below	
Dimensions:	Canopy (Planting Width/East West & North South Spread)	4m - 6m / EW 23.5m NS 18.3m

Measured Height:	14.6m	
	Measured DBH:	0.81m	
	Overall Height Estimate:	3m - 6m	
Threats & Remedies:	Threats:	Garden/lawn maintenance activities.	
	Remedial Action:	Educate land managers about suitable maintenance options in close proximity to the tree.	
Comments:	No comment required.		
	Assessment Completed by:	Gareth Tyson	
	Assessment Completed date:	15 May 2012

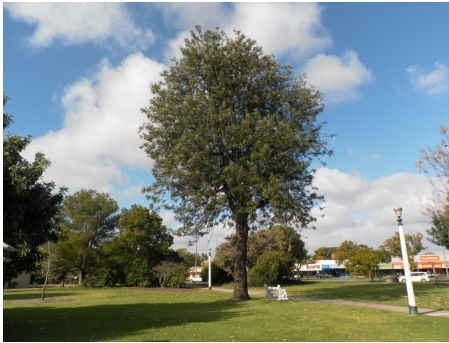
Identification:	Common Name: Silky Oak Genus & Species: <i>Grevillea robusta</i> Tree Group Identifier No: 21 Tree No: 108

Location & Access:	Location (Street Address or Park Name): Access: GIS Coordinates:	
		Henderson Park, Mildura Unrestricted 6216011.6900000004 (N) / 606329.24300000002 (E)
<i>For mapping please refer to Tree Group Identification No 21 on Mildura (Henderson Park-C) town map in Appendix 1</i>		
Assessment:	National Trust Australia (Vic) Heritage Register: National Trust Australia (Vic) Criteria for Classification and Assessment: MPS Heritage Overlay: Heritage Victoria Criteria for Classification and Assessment:	No Location or Context: Contribution to Landscape Aesthetic Value No Referred for Assessment in Stage 2 of MRCC Heritage Study Part B
Field Description:	Tree Health: Tree Structure & Condition: Note:	Good Poor - Lopped Comments below
Dimensions:	Canopy (Planting Width/East West & North South Spread) Measured Height: Measured DBH: Overall Height Estimate:	4m - 6m / EW 14m NS 14.5m 19.2m 0.8m 3m - 6m

Threats & Remedies:	Threats: Remedial Action:	Garden/lawn maintenance activities. Educate land managers about suitable maintenance options in close proximity to the tree. Monitor branch attachment regularly,
Comments:	No comment required. Assessment Completed by: Assessment Completed date:	
		Gareth Tyson 15 May 2012

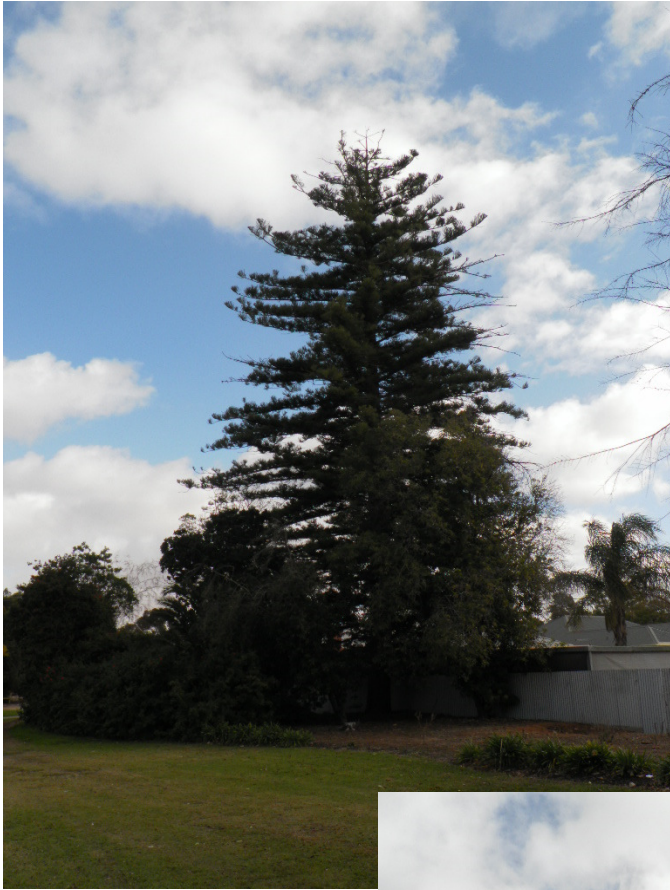
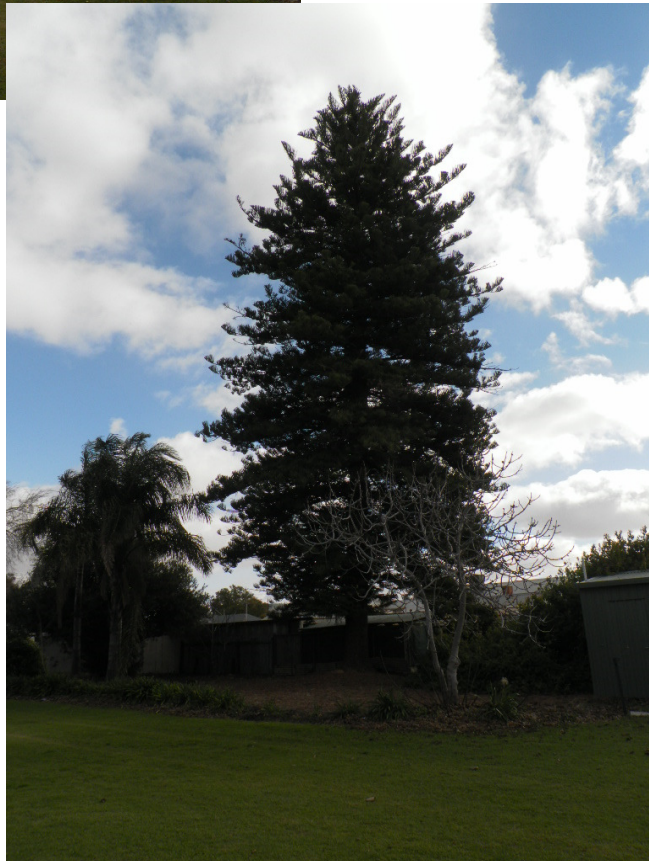
Identification:	Common Name:	Aleppo Pine
	Genus & Species:	Pinus halepensis
	Tree Group Identifier No:	24
	Tree No:	112
Location & Access:	Location (Street Address or Park Name):	Corner of Sixth Street, Mildura and Cureton Avenue, Mildura
	Access:	Unrestricted
	GIS Coordinates:	6217839.5130000003 (N) / 606729.86600000004 (E)
For mapping please refer to Tree Group Identification No 24 on Mildura (Arts Centre-A) town map in Appendix 1		
Assessment:	National Trust Australia (Vic) Heritage Register:	No
	National Trust Australia (Vic) Criteria for Classification and Assessment:	Location or Context: Contribution to Landscape Aesthetic Value
	MPS Heritage Overlay:	No
	Heritage Victoria Criteria for Classification and Assessment:	Referred for Assessment in Stage 2 of MRCC Heritage Study Part B
Field Description:	Tree Health:	Very Good
	Tree Structure & Condition:	Poor - Co-dominant or Bifurcated Stems
	Note:	
Dimensions:	Canopy (Planting Width/East West & North South Spread)	4m - 6m / EW 17.4m NS 17.3m

Measured Height:	16.4m
	Measured DBH:	South 0.6m North 0.78m
	Overall Height Estimate:	3m - 6m
Threats & Remedies:	Threats:	Garden/lawn maintenance activities.
	Remedial Action:	Educate land managers about suitable maintenance options in close proximity to the tree. Minimise damage to the trunk and lower canopy.
Comments:	No comment required.	
	Assessment Completed by:	Gareth Tyson
	Assessment Completed date:	15 May 2012

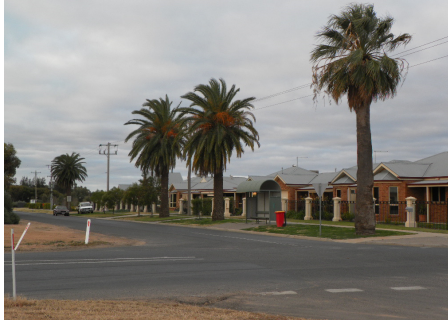
Identification:	Common Name:	Canary Island Date Palm

Genus & Species:	<i>Phoenix canariensis</i>	
	Tree Group Identifier No:	33	
	Tree No:	194-198	
Location & Access:	Location (Street Address or Park Name):	Deakin Avenue, Mildura & Sixteenth Street, Mildura	
	Access:	Unrestricted	
	GIS Coordinates:	6213395.5080000004 (N) / 603763.96699999995 (E)	
For mapping please refer to Tree Group Identification No 33 on Mildura (Key) town map in Appendix 1			
Assessment:	National Trust Australia (Vic) Heritage Register:	No	
	National Trust Australia (Vic) Criteria for Classification and Assessment:	Location or Context: Contribution to Landscape	
	MPS Heritage Overlay:	No	
	Heritage Victoria Criteria for Classification and Assessment:	Referred for Assessment in Stage 2 of MRCC Heritage Study Part B	
Field Description:	Tree Health:	Good	
	Tree Structure & Condition:	Good Structure	
	Note:	Comments below	
Dimensions:	Canopy (Planting Width/East West & North South Spread)	4m - 6m / Not Assessed

Measured Height:	Not Assessed	
	Measured DBH:	Not Assessed	
	Overall Height Estimate:	3m - 6m	
Threats & Remedies:	Threats:	Development of Deakin Avenue into the future, Overhead electric lines..	
	Remedial Action:	Monitor changes to Electric Line Clearance regulations which could impact the trees.	
Comments:	Trees are pruned every 12-18 months to remove dead fronds and fruit.		
	Assessment Completed by:	Gareth Tyson	
	Assessment Completed date:	16 May 2012

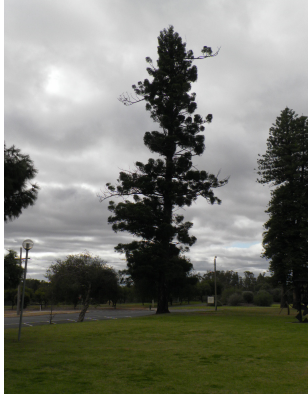
Identification:	Common Name:	Hoop Pine
	Genus & Species:	<i>Araucaria cunninghamii</i>
	Tree Group Identifier No:	34
	Tree No:	199
Location & Access:	Location (Street Address or Park Name):	Rio Vista House, Mildura
	Access:	Unrestricted
	GIS Coordinates:	6217634.9129999997 (N) / 606801.5729999997 (E)

<p>For mapping please refer to Tree Group Identification No 34 on Mildura (Arts Centre-A) town map in Appendix 1</p>		
Assessment:	National Trust Australia (Vic) Heritage Register:	No
	National Trust Australia (Vic) Criteria for Classification and Assessment:	Location or Context: Contribution to Landscape Aesthetic Value
	MPS Heritage Overlay:	No
	Heritage Victoria Criteria for Classification and Assessment:	Referred for Assessment in Stage 2 of MRCC Heritage Study Part B
Field Description:	Tree Health:	Good
	Tree Structure & Condition:	Good Structure
	Note:	Comments below
Dimensions:	Canopy (Planting Width/East West & North South Spread)	4m - 6m / EW 9.7m NS 9.1m

Measured Height:	24m
	Measured DBH:	0.8m
	Overall Height Estimate:	3m - 6m
Threats & Remedies:	Threats:	Garden/lawn maintenance activities.
	Remedial Action:	Educate land managers about the suitable maintenance options in close proximity to the tree to minimise damage to any parts above or below ground.
Comments:	Botanical and common name corrected MJ (2020).	
	Assessment Completed by:	Gareth Tyson
	Assessment Completed date:	16 May 2012

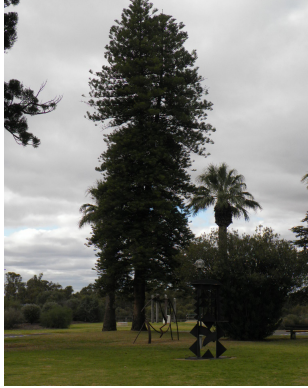
Identification:	Common Name:	Norfolk Island Pine
	Genus & Species:	<i>Araucaria heterophylla</i>
	Tree Group Identifier No:	35
	Tree No:	200
Location & Access:	Location (Street Address or Park Name):	Rio Vista House, Mildura
	Access:	Unrestricted
	GIS Coordinates:	6217642.4809999997 (N) / 606817.6829999996 (E)

<p><i>For mapping please refer to Tree Group Identification No 35 on Mildura (Arts Centre-A) town map in Appendix 1</i></p>		
Assessment:	National Trust Australia (Vic) Heritage Register:	No
	National Trust Australia (Vic) Criteria for Classification and Assessment:	Location or Context: Contribution to Landscape Aesthetic Value
	MPS Heritage Overlay:	Tree covered by HO307 in the Mildura Planning Scheme
	Heritage Victoria Criteria for Classification and Assessment:	Referred for Assessment in Stage 2 of MRCC Heritage Study Part B
Field Description:	Tree Health:	Good
	Tree Structure & Condition:	Good Structure

Note:	Comments below
Dimensions:	Canopy (Planting Width/East West & North South Spread)	4m - 6m / EW 7.9m NS 7.8m
	Measured Height:	22.8m
	Measured DBH:	0.76m
	Overall Height Estimate:	3m - 6m
Threats & Remedies:	Threats:	Garden/lawn maintenance activities.
	Remedial Action:	Educate land managers about the suitable maintenance options in close proximity to the tree to minimise damage to any parts above or below ground.
Comments:	No comment required.	
	Assessment Completed by:	Gareth Tyson
	Assessment Completed date:	16 May 2012

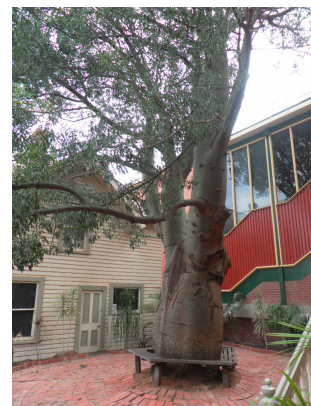
Identification:	Common Name:	Bottle Tree
	Genus & Species:	<i>Brachychiton rupestris</i>
	Tree Group Identifier No:	41
	Tree No:	266
Location & Access:	Location (Street Address or Park Name):	199 Cureton Avenue, Mildura Rio Vista House, Mildura (Courtyard at rear)
	Access:	Access may be limited to times when the location is open to the public.
	GIS Coordinates:	6217544.9450000003 (N) / 606765.00899999996 (E)
<i>For mapping please refer to Tree Group Identification No 41 on Mildura (Arts Centre-A) town map in Appendix 1</i>		
Assessment:	National Trust Australia (Vic) Heritage Register:	No
	National Trust Australia (Vic) Criteria for Classification and Assessment:	Location or Context: Contribution to Landscape Rare or Localised
	MPS Heritage Overlay:	No
	Heritage Victoria Criteria for Classification and Assessment:	Referred for Assessment in Stage 2 of MRCC Heritage Study Part B
Field Description:	Tree Health:	Good

Tree Structure & Condition:	Poor - Co-dominant or Bifurcated Stems
	Note:	Comments below
Dimensions:	Canopy (Planting Width/East West & North South Spread)	4m - 6m / EW 10m NS 8m
	Measured Height:	11.8m
	Measured DBH:	1.42m
	Overall Height Estimate:	3m - 6m
Threats & Remedies:	Threats:	Redevelopment of Rio Vista House and the courtyard area.
	Remedial Action:	Ensure that the tree is protected during any redevelopment
Comments:	No comment required.	
	Assessment Completed by:	Gareth Tyson
	Assessment Completed date:	29 June 2012

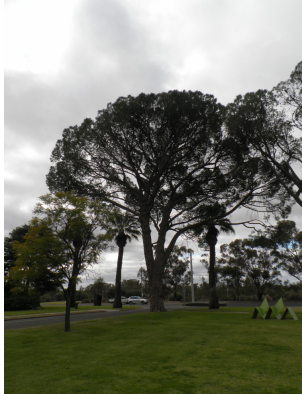
Identification:	Common Name:	Stone Pine
	Genus & Species:	<i>Pinus pinea</i>
	Tree Group Identifier No:	42
	Tree No:	267
Location & Access:	Location (Street Address or Park Name):	Rio Vista House, Mildura (Entrance)
	Access:	Unrestricted
	GIS Coordinates:	6217595.8770000003 (N) / 606841.7669999999 (E)

<p><i>For mapping please refer to Tree Group Identification No 42 on Mildura (Arts Centre-A) town map in Appendix 1</i></p>		
Assessment:	National Trust Australia (Vic) Heritage Register:	No
	National Trust Australia (Vic) Criteria for Classification and Assessment:	Location or Context: Contribution to Landscape
	MPS Heritage Overlay:	No
	Heritage Victoria Criteria for Classification and Assessment:	Referred for Assessment in Stage 2 of MRCC Heritage Study Part B
Field Description:	Tree Health:	Good
	Tree Structure & Condition:	Poor - Co-dominant or Bifurcated Stems
	Note:	Comments below
Dimensions:	Canopy (Planting Width/East West & North South Spread)	4m - 6m / EW 25.5m NS 23m

Measured Height:	19m
	Measured DBH:	1.19m
	Overall Height Estimate:	3m - 6m
Threats & Remedies:	Threats:	Redevelopment of Rio Vista and landscaping
	Remedial Action:	Ensure that the tree is protected during any redevelopment
Comments:	No comment required.	
	Assessment Completed by:	Gareth Tyson
	Assessment Completed date:	29 June 2012

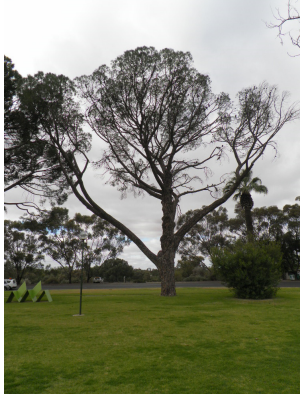
Identification:	Common Name:	Stone Pine

Genus & Species:	<i>Pinus pinea</i>	
	Tree Group Identifier No:	43	
	Tree No:	268	
Location & Access:	Location (Street Address or Park Name):	Rio Vista House, Mildura (Front lawn near entrance)	
	Access:	Unrestricted	
	GIS Coordinates:	6217580.3360000001 (N) / 606852.47900000005 (E)	
<i>For mapping please refer to Tree Group Identification No 43 on Mildura (Arts Centre-A) town map in Appendix 1</i>			
Assessment:	National Trust Australia (Vic) Heritage Register:	No	
	National Trust Australia (Vic) Criteria for Classification and Assessment:	Location or Context: Contribution to Landscape	
	MPS Heritage Overlay:	No	
	Heritage Victoria Criteria for Classification and Assessment:	Referred for Assessment in Stage 2 of MRCC Heritage Study Part B	
Field Description:	Tree Health:	Poor	
	Tree Structure & Condition:	Good Structure	
	Note:	Comments below	
Dimensions:	Canopy (Planting Width/East West & North South Spread)	4m - 6m / EW 20m NS 16m

Measured Height:	17m	
	Measured DBH:	1.15m	
	Overall Height Estimate:	3m - 6m	
Threats & Remedies:	Threats:	Redevelopment of Rio Vista and landscaping	
	Remedial Action:	Ensure that the tree is protected during any redevelopment	
Comments:	No comment required.		
	Assessment Completed by:	Gareth Tyson	
	Assessment Completed date:	29 June 2012

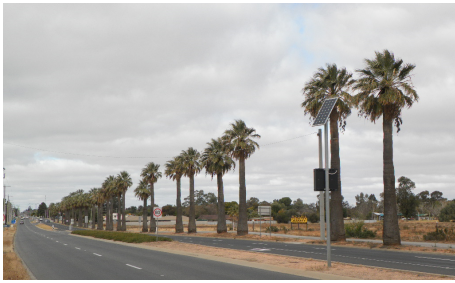
Identification:	Common Name:	Desert Fan Palm		
	Genus & Species:	<i>Washingtonia filifera</i>		
	Tree Group Identifier No:	46		
	Tree No:	287-317

Location (Street Address or Park Name):	Fifteenth Street, Irymple (Between Karadoc Avenue & Sandilong Avenue, Irymple)
			Access:	Unrestricted
Location & Access:	GIS Coordinates:	6211610.1770000001 (N) / 607323.0849999996 (E)		
<p><i>For mapping please refer to Tree Group Identification No 46 on Irymple (Key) town map in Appendix 1</i></p>				
Assessment:	National Trust Australia (Vic) Heritage Register:	No		
	National Trust Australia (Vic) Criteria for Classification and Assessment:	Location or Context: Contribution to Landscape Aesthetic Value		
	MPS Heritage Overlay:	No		
	Heritage Victoria Criteria for Classification and Assessment:	Referred for Assessment in Stage 2 of MRCC Heritage Study Part B		
Field Description:	Tree Health:	Very Good

Tree Structure & Condition:	Good Structure		
	Note:	Comments below		
Dimensions:	Canopy (Planting Width/East West & North South Spread)	4m - 6m / Not Assessed		
	Measured Height:	Not Assessed		
	Measured DBH:	Not Assessed		
	Overall Height Estimate:	3m - 6m		
Threats & Remedies:	Threats:	287-293 Garden/lawn maintenance activities. 295-317 Development of adjoining vacant block.		
	Remedial Action:	287-293 Educate land managers about suitable maintenance options in close proximity to the tree. Minimise damage to base of the palm trees. 295-317 Ensure that the trees are protected during any redevelopment of the site. This avenue appears to have been planted in pairs. There is an opportunity to fill in some gaps where trees have not survived.		
Comments:	Trees are pruned every 12-18 months to remove dead fronds and fruit.			
Assessment Completed by:		Gareth Tyson		
Assessment Completed date:		14 May 2012

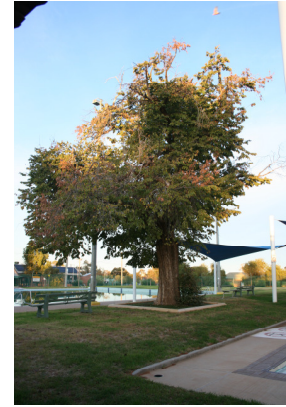
Identification:	Common Name:	Elm
	Genus & Species:	<i>Ulmus sp.</i>
	Tree Group Identifier No:	51
	Tree No:	372
Location & Access:	Location (Street Address or Park Name):	Merbein Swimming Pool, Merbein
	Access:	Access may be limited to times when pool is open to the public for use.
	GIS Coordinates:	6218929.6409999998 (N) / 597107.87399999995 (E)
<p><i>For mapping please refer to Tree Group Identification No 51 on Merbein (Key) town map in Appendix 1</i></p>		
Assessment:	National Trust Australia (Vic) Heritage Register:	No
	National Trust Australia (Vic) Criteria for Classification and Assessment:	Location or Context: Contribution to Landscape Rare or Localised
	MPS Heritage Overlay:	No
	Heritage Victoria Criteria for Classification and Assessment:	Referred for Assessment in Stage 2 of MRCC Heritage Study Part B
Field Description:	Tree Health:	Poor
	Tree Structure & Condition:	Good Structure
	Note:	Comments below

Dimensions:	Canopy (Planting Width/East West & North South Spread)	4m - 6m / EW 12m NS 11m
	Measured Height:	11m
	Measured DBH:	0.91m
	Overall Height Estimate:	3m - 6m
Threats & Remedies:	Threats:	Positioned in a high use area over the Summer period.
	Remedial Action:	Inspect tree regularly to manage risk associated with any part or whole tree failure in high use area.
Comments:	No comment required.	
	Assessment Completed by:	Gareth Tyson
	Assessment Completed date:	17 May 2012

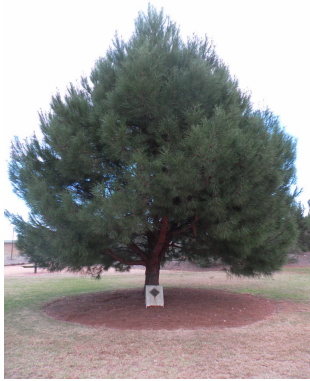
Identification:	Common Name:	Turkish Pine
	Genus & Species:	<i>Pinus brutia</i>
	Tree Group Identifier No:	54
	Tree No:	375
Location & Access:	Location (Street Address or Park Name):	Kenny Park, Merbein (Near Rotunda)
	Access:	Unrestricted
	GIS Coordinates:	6218935.54 (N) / 597221.5949999997 (E)

<i>For mapping please refer to Tree Group Identification No 54 on Merbein (Key) town map in Appendix 1</i>		
Assessment:	National Trust Australia (Vic) Heritage Register:	No
	National Trust Australia (Vic) Criteria for Classification and Assessment:	Location or Context: Contribution to Landscape Historical Value: World War 1
	MPS Heritage Overlay:	No
	Heritage Victoria Criteria for Classification and Assessment:	Referred for Assessment in Stage 2 of MRCC Heritage Study Part B
Field Description:	Tree Health:	Good
	Tree Structure & Condition:	Poor - Co-dominant or Bifurcated Stems
	Note:	No central leader resulting in current shape which is more like a large shrub than an upright tree.

Dimensions:	Canopy (Planting Width/East West & North South Spread)	4m - 6m / EW 8m NS 8m
	Measured Height:	9m
	Measured DBH:	0.48m @ 800mm from ground
	Overall Height Estimate:	3m - 6m
Threats & Remedies:	Threats:	As a result of the low and spreading branches as opposed to the central leader the tree will in time out grow its mulch ring and encroach on the adjoining lawn.
	Remedial Action:	Recommend that as the tree continues to grow the plaque be shifted from beneath the tree out further and the mulch ring be extended to eliminate the need for undertimming to allow for lawn maintenance.
Comments:	Plaque beneath the tree reads: <i>From the ORIGINAL LONE PINE ON GALLIPOLLI. Grown in the jubilee year 1965. Planted in memory of departed comrades LEST WE FORGET.</i>	
	Assessment Completed by:	Gareth Tyson
	Assessment Completed date:	29 June 2012

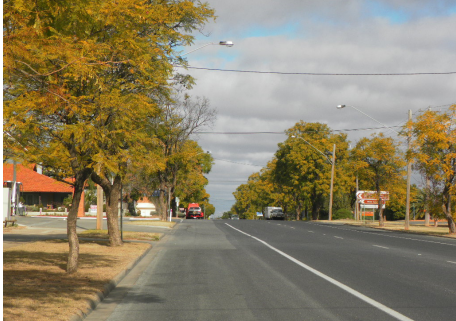
Identification:	Common Name:	Jacaranda

Genus & Species:	Jacaranda mimosifolia	
	Tree Group Identifier No:	55	
	Tree No:	467-477	
Location & Access:	Location (Street Address or Park Name):	Jacaranda Street, Red Cliffs (Nature strip north east side)	
	Access:	Unrestricted	
	GIS Coordinates:	6202342.8640000001 (N) / 609173.19700000004 (E)	
For mapping please refer to Tree Group Identification No 55 on Red Cliffs (Barclay Square) town map in Appendix 1			
Assessment:	National Trust Australia (Vic) Heritage Register:	No	
	National Trust Australia (Vic) Criteria for Classification and Assessment:	Location or Context: Contribution to Landscape	
	MPS Heritage Overlay:	No	
	Heritage Victoria Criteria for Classification and Assessment:	Referred for Assessment in Stage 2 of MRCC Heritage Study Part B	
Field Description:	Tree Health:	467-468, 470-477 Good 469 Poor	
	Tree Structure & Condition:	Good Structure

Note:	Comments below	
Dimensions:	Canopy (Planting Width/East West & North South Spread)	4m - 6m / Not Assessed	
	Measured Height:	Not Assessed	
	Measured DBH:	Not Assessed	
	Overall Height Estimate:	3m - 6m	
Threats & Remedies:	Threats:	Garden/lawn maintenance activities.	
	Remedial Action:	Educate land managers about the suitable maintenance options in close proximity to the tree to minimise damage to any parts above or below ground.	
Comments:	No comment required.		
	Assessment Completed by:	Gareth Tyson	
	Assessment Completed date:	16 June 2012

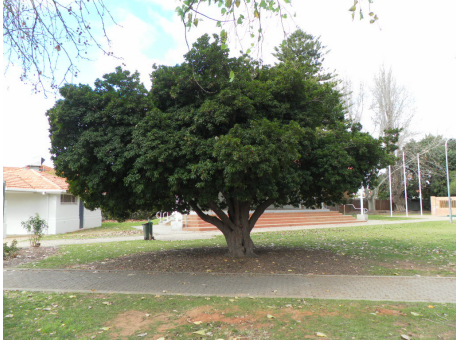
Identification:	Common Name:	Irish Strawberry
	Genus & Species:	Arbutus unedo
	Tree Group Identifier No:	60
	Tree No:	487

Location & Access:	Location (Street Address or Park Name):	Barclay Square, Red Cliffs
	Access:	Unrestricted
	GIS Coordinates:	6203118.784 (N) / 609282.79099999997 (E)

Field Description:	Tree Health:	Good
	Tree Structure & Condition:	Good Structure
	Note:	Comments below

Threats & Remedies:	Threats:	Garden/lawn maintenance activities.
	Remedial Action:	Educate land managers about the suitable maintenance options in close proximity to the tree to minimise damage to any parts above or below ground.

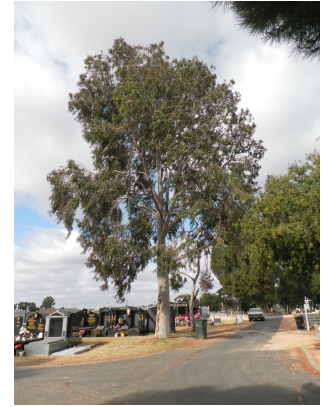
Identification:	Common Name:	Lemon Scented Gum
	Genus & Species:	<i>Corymbia citriodora</i>
	Tree Group Identifier No:	65
	Tree No:	507
Location & Access:	Location (Street Address or Park Name):	Nichols Point Cemetery, Nichols Point
	Access:	Unrestricted
	GIS Coordinates:	6215780.5949999997 (N) / 612187.973 (E)
<p><i>For mapping please refer to Tree Group Identification No 65 on Nichols Point (Key) town map in Appendix 1</i></p>		
Assessment:	National Trust Australia (Vic) Heritage Register:	No
	National Trust Australia (Vic) Criteria for Classification and Assessment:	Location or Context: Contribution to Landscape Aesthetic Value Historical Value
	MPS Heritage Overlay:	No
	Heritage Victoria Criteria for Classification and Assessment:	Referred for Assessment in Stage 2 of MRCC Heritage Study Part B
Field Description:	Tree Health:	Very Good
	Tree Structure & Condition:	Good Structure
	Note:	Comments below

Dimensions:	Canopy (Planting Width/East West & North South Spread)	4m - 6m / Not Assessed
	Measured Height:	Not Assessed
	Measured DBH:	Not Assessed
	Overall Height Estimate:	3m - 6m
Threats & Remedies:	Threats:	Compaction of site due to limited off road parking inside the cemetery grounds.
	Remedial Action:	Formalise site protection around the tree possibly including bollards and mulch.
Comments:		No comment required.
	Assessment Completed by:	Gareth Tyson
	Assessment Completed date:	15 May 2012
